# PHYSICAL NEEDS ASSESSMENT

**MURRAY DUPLEXES**  
1419-1457 Murray Road  
McKinleyville, California 95519

**Redwood Community Action Agency**  
904 G Street  
Eureka, California 95501

January 24, 2019

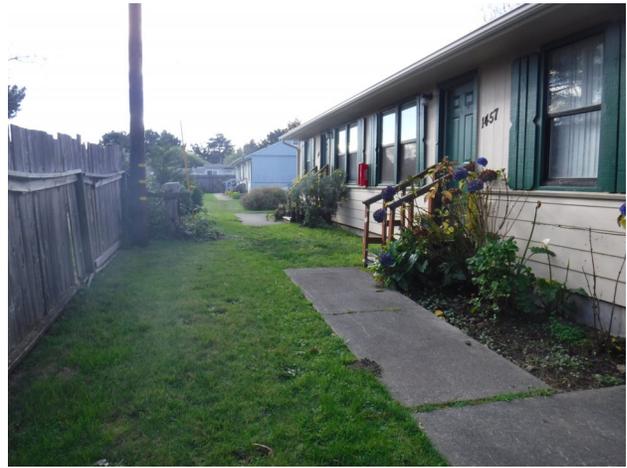
2. East perimeter of the Property, view south. Note damaged wood fencing.

- Provide improved property identification signage, site map, and unit signage throughout.
- Replace damaged wood fencing at perimeter and units.
- The paving at the attached carports, open parking areas, and drive aisles is poorly sloped, or otherwise damaged. Regrade to promote proper water flow. Following repairs, seal and restripe all parking areas.

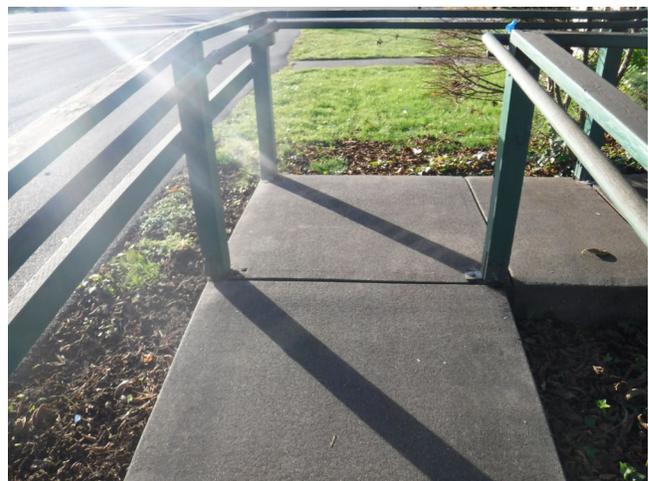
6. Non-conforming ramp at accessible unit entry.

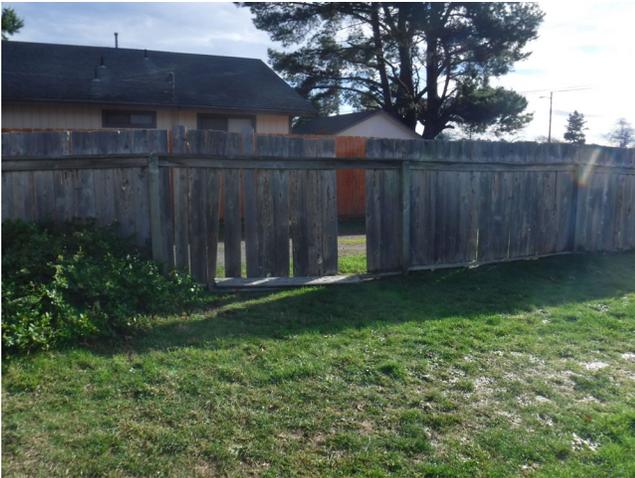
9. Damaged and missing site fencing.

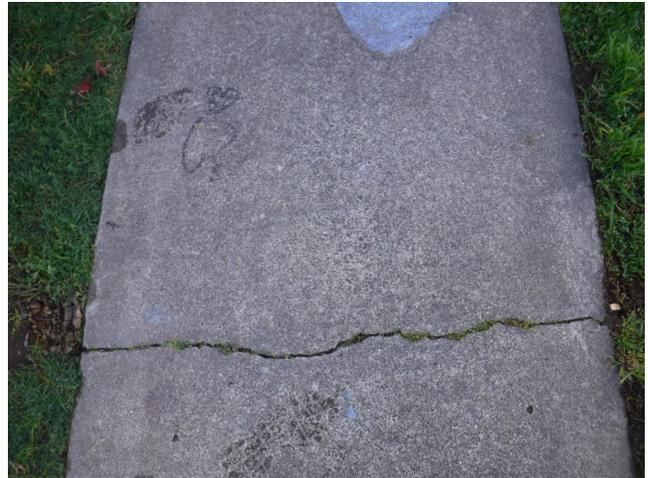
- There are areas of damaged walkways throughout the Property. Locations are uneven and present trip hazards. Replace any damaged or uneven walkways, and add new concrete walkways where needed to provide a safe path of travel throughout the site.

10. Damaged walkway.

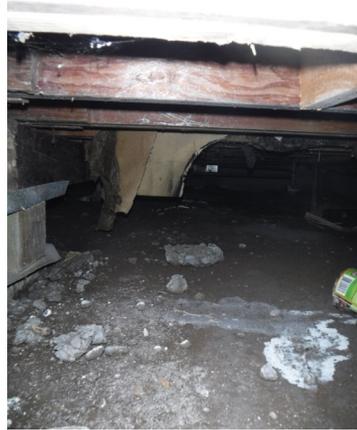
- Due to reported lack of code conforming access and clearances at the crawlspaces, lack of vapor barrier, and evidence of floor movement in a portion of the units, a detailed inspection and redesign or upgrade to the structural foundation systems is recommended. Reinforcement of the existing structures, addition of a vapor barrier, excavation to provide adequate access and clearances, improved ventilation, replace rotted wood components, add mechanical ventilation if deemed necessary. Design and feasibility analysis required. Evidence of standing water, mold growth on soil and insulation, as well a lack of insulation, were observed.

14. Typical crawl space conditions, not damaged insulation, waste, debris and moisture.

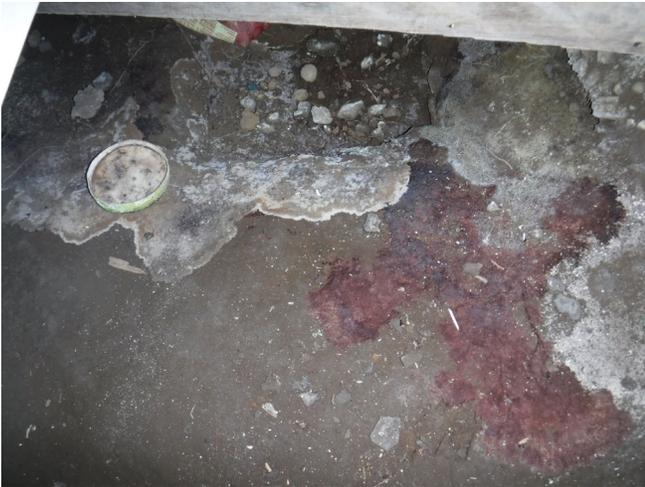
- Management reported ongoing issues with mildew, and potential mold growth was observed in some crawlspace areas that were accessed. Anticipate some level of remediation, at a minimum replacing framing and finishes and cleaning of mold in the structures, during rehab.

- Due to lack of vapor barrier in the crawl spaces, and evidence of wood damage at limited floor areas, a full wood destroying pest survey is recommended.

15. Debris in crawl space and mildew or mold on soil, lack of vapor barrier.

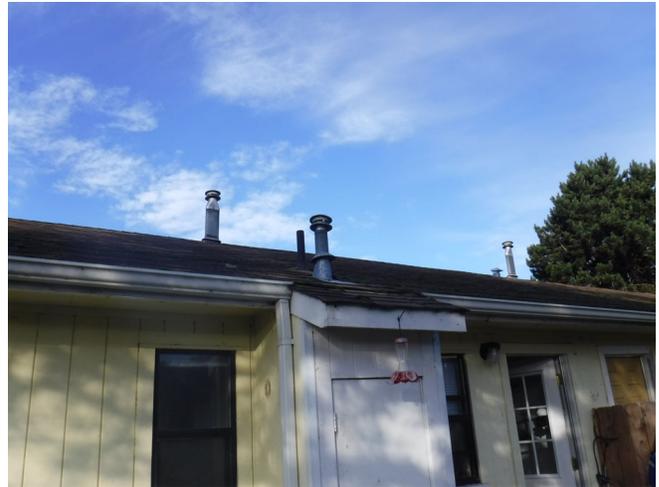
16. Typical older roofing conditions. Note exterior water heater closet.

- Prepare and paint all exteriors including carports and exterior trim elements.
- The roof coverings have reached the end of their useful life based on surface wear and age. Replace with a minimum 35-year dimensional shingle. Replace all flashings. Consider radiant barrier for improved insulation factor.

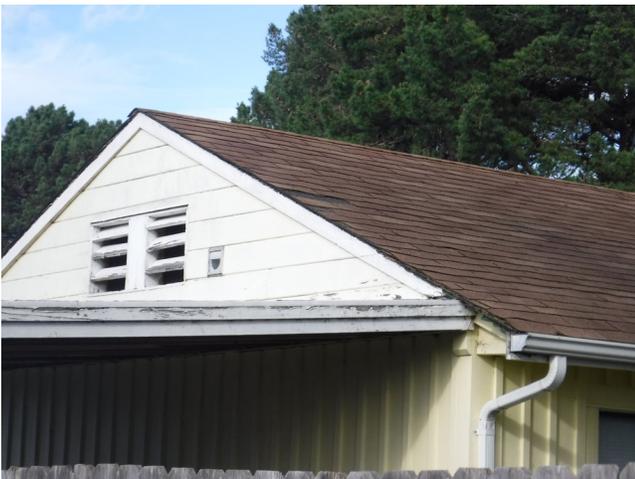
17. Worn and missing roofing, peeling paint and damaged siding.

- Based on the age, anticipate at least partial site water and waste line replacements during rehab.
- Given the age of the siding, the plan to significantly rehab the structures, and for improved long-term durability, removal and replacement of any damaged siding, waterproofing and other exterior trim elements is recommended.

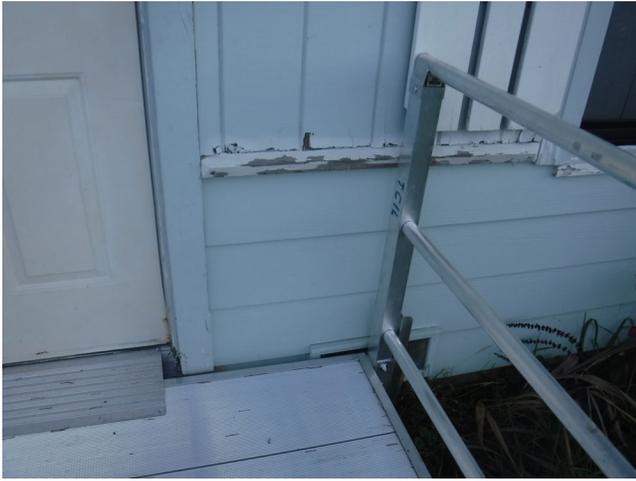
19. Peeling paint at exterior siding and trim.

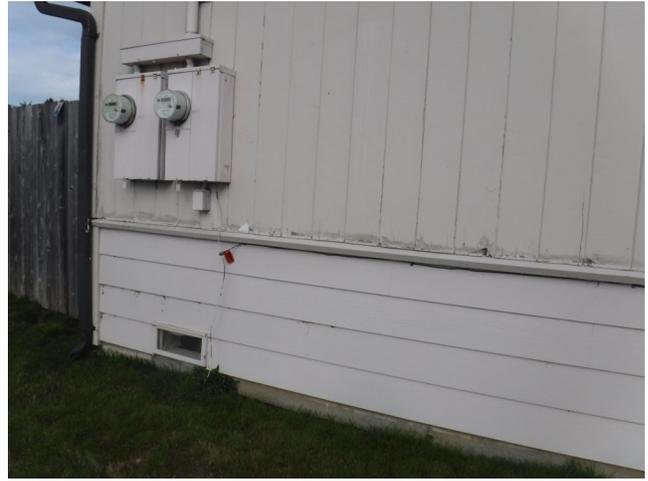
20. Damaged siding and individual electrical meters.

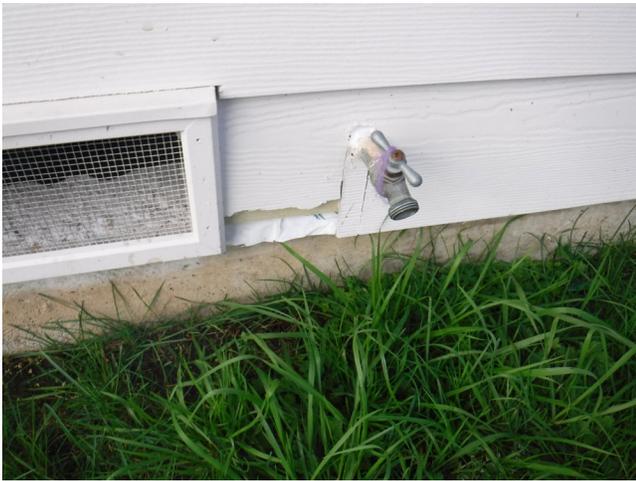
21. Damaged siding.

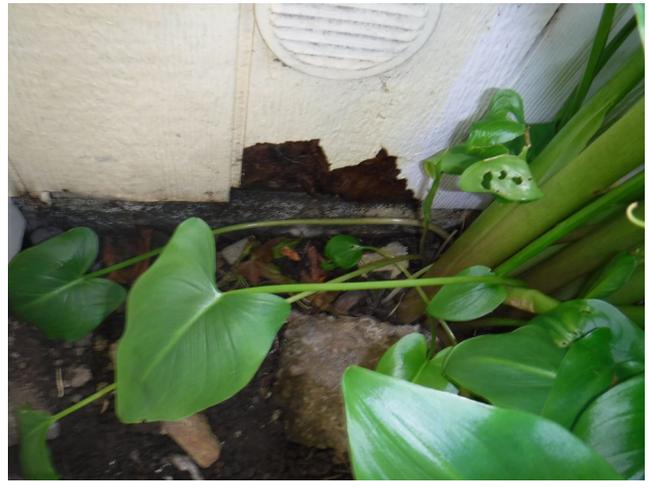
22. Damaged siding

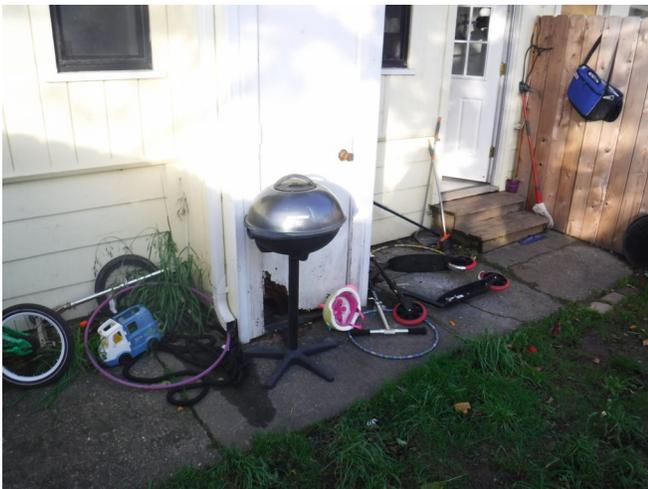
23. Damaged water heater enclosure door and typical rear entry to the units.

- Replace roof drainage components and extend leaders or add tight lines as part of the drainage upgrades.
- Remove and replace the exterior doors with insulated metal fixtures for improved insulation of the units and durability. Provide new door locks and hardware. Front and rear entry doors at each unit. Replace water heater closet doors with more durable system.

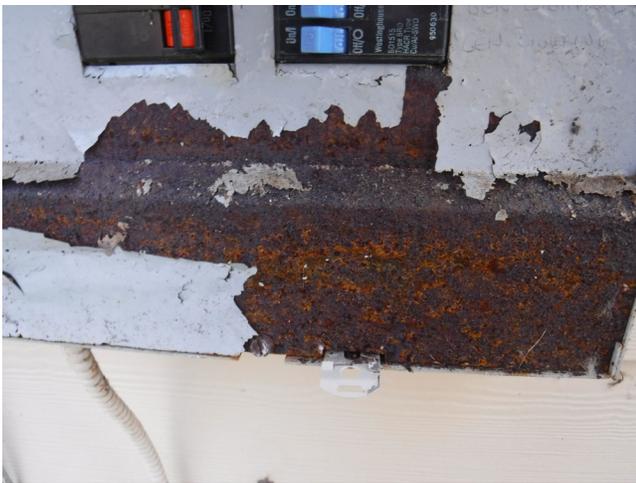
27. Rust damaged electrical subpanel at meter.

- Install new electrical panels and subpanels, GFCI, ARC Fault, outlets and switches.
- Replace all unit lighting with LED for improved energy efficiency.

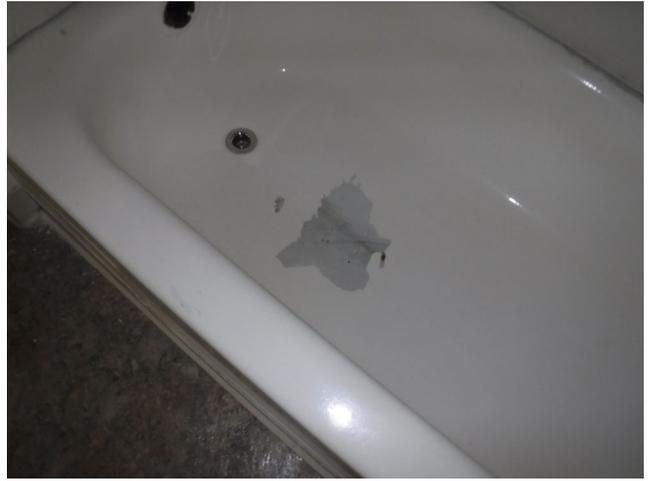
- The tubs and enclosures are stained, worn and in need of refurbishment and in some cases complete replacement. The existing accessible unit shower can be refurbished.

44. Peeling finish at bathroom tub.
